Feather River, RM 28.5R (LM 14.5, Sutter County LD 1 West)

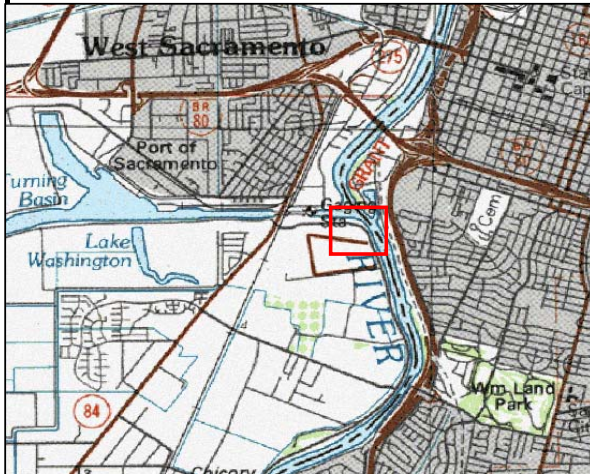
Sacramento River, RM 57.2R

Criteria	Score	Notes
Bank Slope (*2)	3	1.5:1 slope
Berm Width (*2) - Estimated	5	0 to 10 ft
Location of erosion	4	toe and lower bank
Bank Stability	5	vertical sections and caves
Site Relative to Bend	0	inside of a bend
Vegetation Cover	1	70%
Tree Hazard	5	large trees, exposed roots and leaning
Soil Type (*2)	4	sands and silts
Velocity (*2)	4	5.16 ft/s
Human Usage	4	weekly
Erosion Hazard	51	Calculate Erosion Hazard

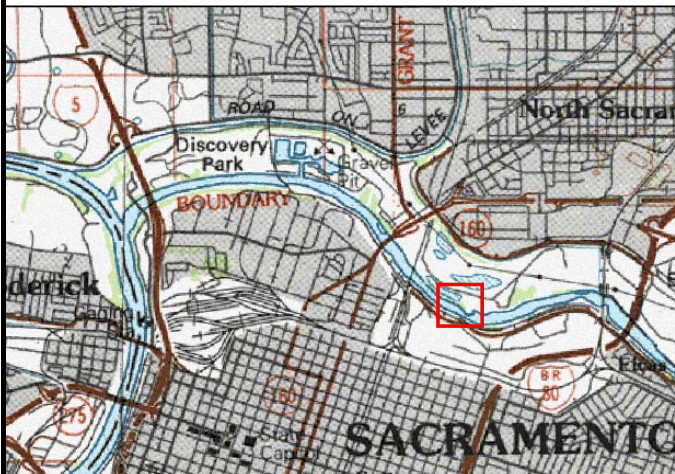
Lower American River, RM 2.8L

Criteria	Score	Notes
Bank Slope (*2)	4	1:1 slope
Berm Width (*2) - Estimated	2	10 to 20 ft
Location of erosion	4	whole bank and toe
Bank Stability	5	caves greater than 4 ft and vertical sections
Site Relative to Bend	2	just downstream of a bend
Vegetation Cover	2	50 -60%
Tree Hazard	5	trees with exposed roots, some leaning
Soil Type (*2)	4	sands and silts
Velocity (*2)	3	3.39 ft/s
Human Usage	5	Debris and paths indicative of daily use
Erosion Hazard	49	Calculate Erosion Hazard

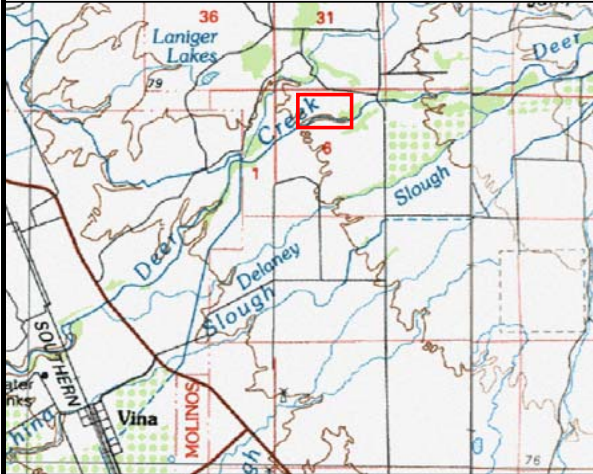
Deer Creek, LM 0.9 (Tehama County Unit 2 North)

Criteria	Score	Notes
Bank Slope (*2)	5	near vertical
Berm Width (*2) - Estimated	2	10 to 15 ft
Location of erosion	4	toe and bank
Bank Stability	5	Vertical sections, greater than half bank height and animal holes
Site Relative to Bend	3	outside of a gentle bend
Geomorph	0	tight levees, no migration expected
Vegetation Cover	4	minimal veg
Tree Hazard	5	large leaning trees with exposed roots
Soil Type (*2)	3	sands and cobbles
Velocity (*2)	4	~5+ ft/s
Human Usage	0	rare
Erosion Hazard	49	Calculate Erosion Hazard

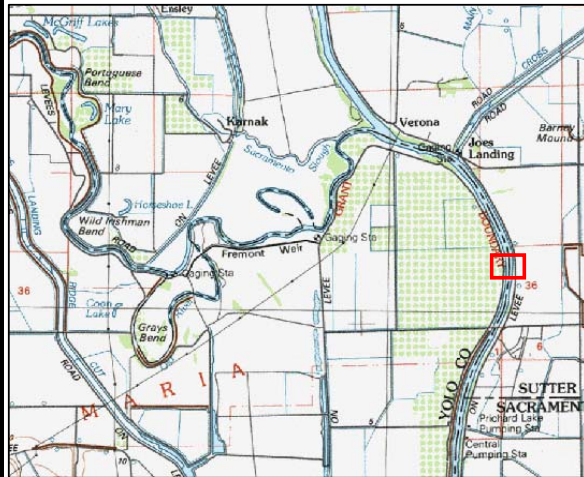
Sacramento River, RM 77.2L

Criteria	Score	Notes
Bank Slope (*2)	4	less than 1:1
Berm Width (*2) - Estimated	0	30 ft
Location of erosion	3	toe
Bank Stability	5	vertical sections greater than half bank height and animal holes
Site Relative to Bend	3	outside of a gentle bend
Vegetation Cover	4	less than 20%
Tree Hazard	5	exposed roots, trees leaning
Soil Type (*2)	4	sands and silts
Velocity (*2)	4	5.01 ft/s
Human Usage	4	weekly, paths and adjacent to road
Erosion Hazard	48	Calculate Erosion Hazard

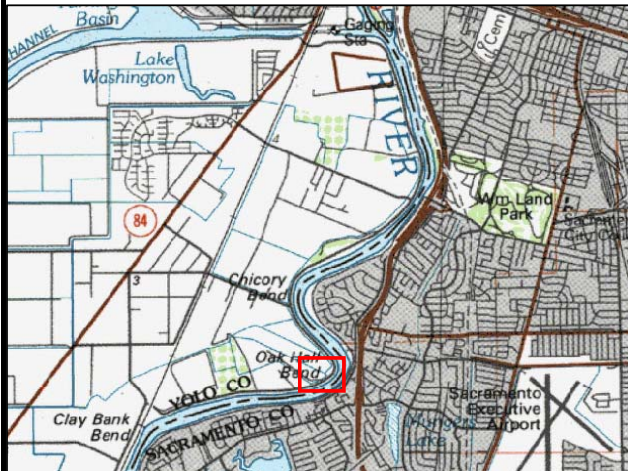
Sacramento River, RM 53.5R

Criteria	Score	Notes
Bank Slope (*2)	4	1:1 slope
Berm Width (*2) - Estimated	3	5 ft of berm
Location of erosion	4	whole bank and toe
Bank Stability	2	small vertical sections
Site Relative to Bend	0	inside of a bend
Vegetation Cover	2	50%
Tree Hazard	4	large trees with exposed roots
Soil Type (*2)	4	sand and silts
Velocity (*2)	4	6.02 ft/s
Human Usage	5	daily, parking area on levee, paths down, debris
Erosion Hazard	47	Calculate Erosion Hazard

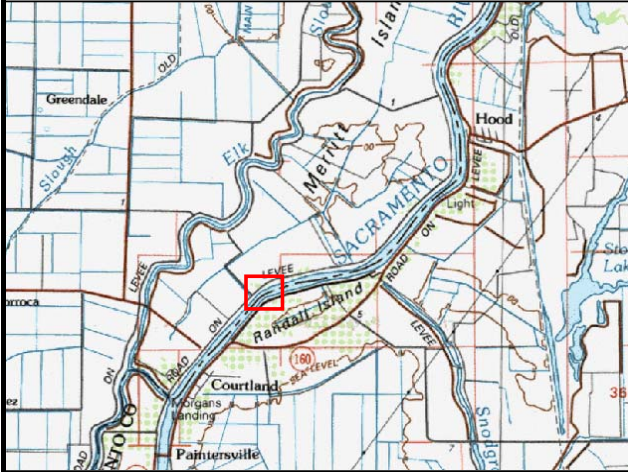
Sacramento River, RM 35.4L

Criteria	Score	Notes
Bank Slope (*2)	3	1.5:1 slope
Berm Width (*2) - Estimated	5	no berm
Location of erosion	4	toe
Bank Stability	5	vertical sections and caves
Site Relative to Bend	0	inside of a bend
Vegetation Cover	1	70%
Tree Hazard	1	young trees
Soil Type (*2)	4	sands and silts
Velocity (*2)	4	6.52 ft/s
Human Usage	4	weekly
Erosion Hazard	47	Calculate Erosion Hazard

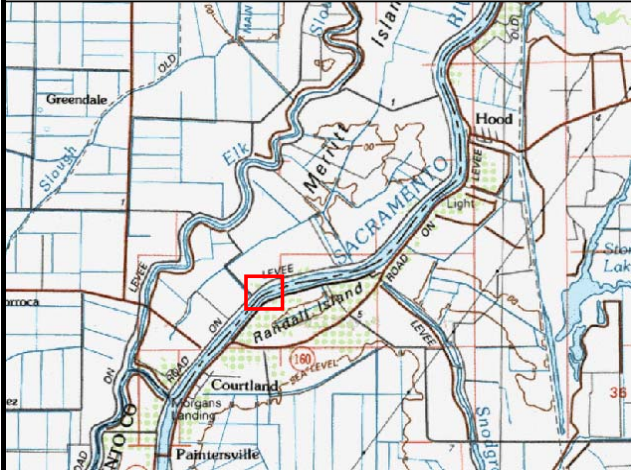
Sacramento River, RM 35.4R

Criteria	Score	Notes
Bank Slope (*2)	2	2:1 slope
Berm Width (*2) - Estimated	5	no berm
Location of erosion	5	toe and underwater
Bank Stability	4	vertical sections greater than half bank height
Site Relative to Bend	3	outside of a greater than 90 degree bend
Vegetation Cover	2	50%
Tree Hazard	1	lone small tree
Soil Type (*2)	4	sands and silts
Velocity (*2)	4	6.52 ft/s
Human Usage	1	steep sections, occasional usage
Erosion Hazard	46	Calculate Erosion Hazard

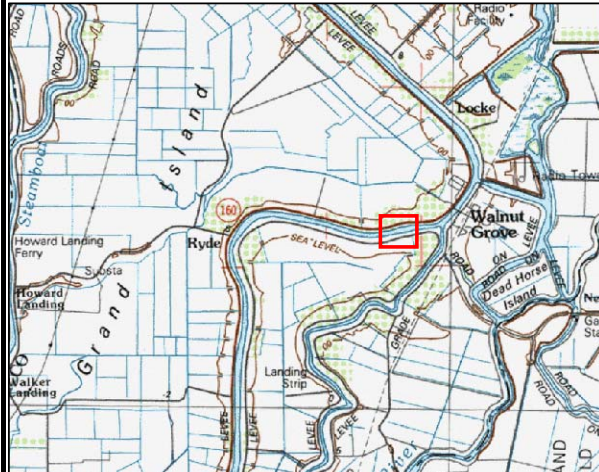
Sacramento River, RM 26.0L

Criteria	Score	Notes
Bank Slope (*2)	4	1:1 or less
Berm Width (*2) - Estimated	5	0 to 50 ft
Location of erosion	5	bank, toe, and underwater
Bank Stability	4	vertical sections, greater than half bank height
Site Relative to Bend	1	straight
Vegetation Cover	1	70 to 80%
Tree Hazard	4	trees with exposed roots
Soil Type (*2)	2	clays and silts
Velocity (*2)	4	5.13 ft/s
Human Usage	1	occassional
Erosion Hazard	46	Calculate Erosion Hazard

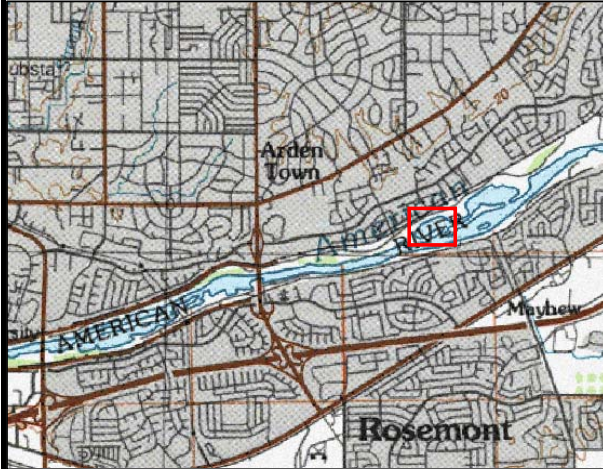
Lower American River, RM 10.6L

Criteria	Score	Notes
Bank Slope (*2)	5	near vertical
Berm Width (*2) - Estimated	2	15 to 20 ft
Location of erosion	2	whole bank
Bank Stability	5	tree popouts and vertical sections
Site Relative to Bend	1	straight
Vegetation Cover	1	80%
Tree Hazard	5	large trees, exposed roots, and leaning
Soil Type (*2)	4	sands and silts
Velocity (*2)	3	3.94 ft/s
Human Usage	4	weekly, trails
Erosion Hazard	46	Calculate Erosion Hazard

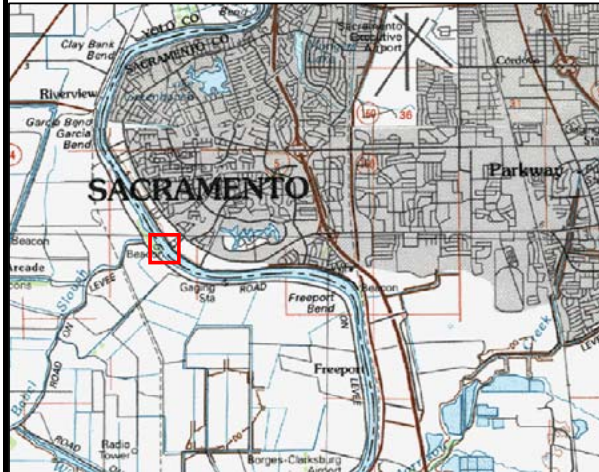
Sacramento River, RM 49.7L

Criteria	Score	Notes
Bank Slope (*2)	3	1.5:1 slope
Berm Width (*2) - Estimated	2	10 ft of berm
Location of erosion	5	bank, toe, and underwater
Bank Stability	2	some small vertical sections
Site Relative to Bend	1	straight
Vegetation Cover	1	60%
Tree Hazard	4	large trees with exposed roots
Soil Type (*2)	5	silts
Velocity (*2)	4	5.6 ft/s (UNET)
Human Usage	4	bike path on top, weekly
Erosion Hazard	45	Calculate Erosion Hazard

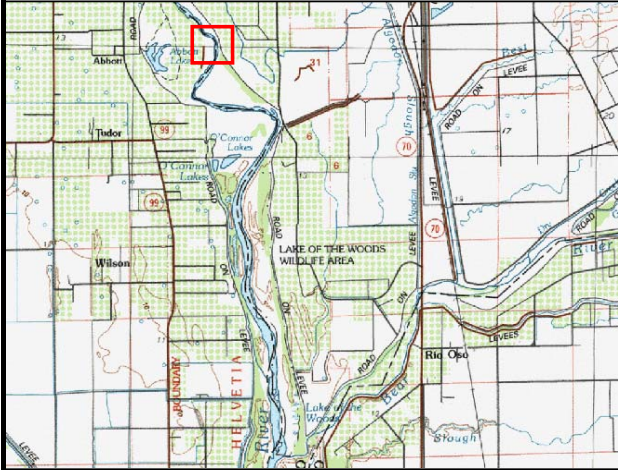
Feather River, RM 19.7L

Criteria	Score	Notes
Bank Slope (*2)	4	1:1 slope or less
Berm Width (*2) - Estimated	0	50 ft
Location of erosion	4	whole bank and toe
Bank Stability	5	caves, greater than 4 ft and vertical sections
Site Relative to Bend	3	outside of a greater than 90 degree bend
Vegetation Cover	3	40 to 50%
Tree Hazard	5	large trees with exposed roots and trees sliding down the bank
Soil Type (*2)	4	sands and silts
Velocity (*2)	4	5.34 ft/s
Human Usage	1	rather steep, not too accessible, occassional
Erosion Hazard	45	Calculate Erosion Hazard

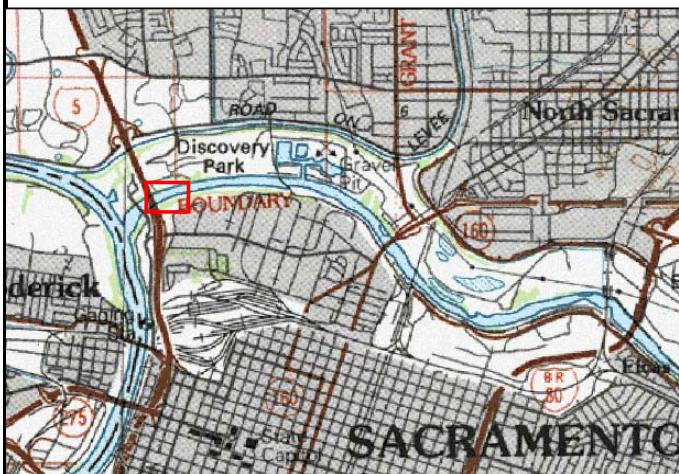
Lower American River, RM 0.3L

Criteria	Score	Notes
Bank Slope (*2)	3	1.5:1 slope
Berm Width (*2) - Estimated	3	6 to 30 ft
Location of erosion	4	bank and toe
Bank Stability	0	no stability issues
Site Relative to Bend	0	inside of a slight bend
Vegetation Cover	3	about 40 %
Tree Hazard	5	large trees with exposed roots, some leaning
Soil Type (*2)	4	sands and silts
Velocity (*2)	4	5.2 ft/s
Human Usage	5	Bike path on top of levee, trails down, trash present, daily use
Erosion Hazard	45	Calculate Erosion Hazard

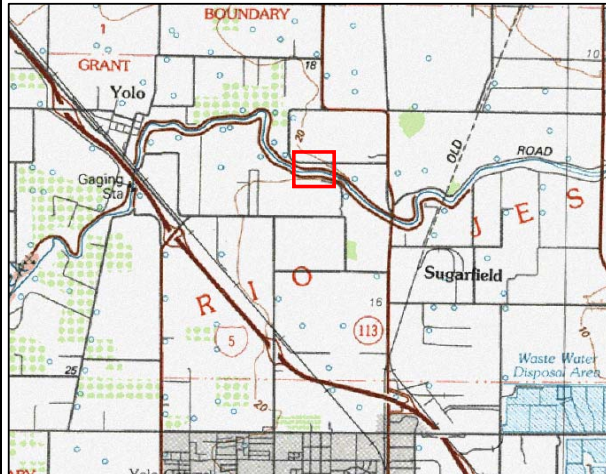
Cache Creek, LM 3.9L

Criteria	Score	Notes
Bank Slope (*2)	4	less than 1:1
Berm Width (*2) - Estimated	2	10 to 25 ft
Location of erosion	4	whole bank and toe
Bank Stability	5	vertical sections and caves
Site Relative to Bend	1	straight
Vegetation Cover	3	30%
Tree Hazard	4	large trees with exposed roots
Soil Type (*2)	4	sands and silts
Velocity (*2)	4	6 ft/s
Human Usage	0	rare
Erosion Hazard	45	Calculate Erosion Hazard

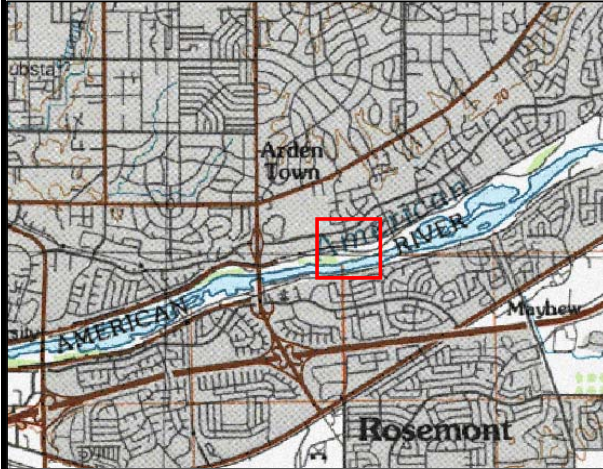
Lower American River, RM 10.0L

Criteria	Score	Notes
Bank Slope (*2)	3	1.5:1 slope
Berm Width (*2) - Estimated	2	10 to 15 ft
Location of erosion	2	lower bank
Bank Stability	2	vertical sections, less than half bank height
Site Relative to Bend	1	straight
Vegetation Cover	1	60%
Tree Hazard	5	large trees, some exposed roots, some leaning
Soil Type (*2)	4	sands and silts
Velocity (*2)	5	8.74 ft/s
Human Usage	5	daily, people on banks, lots of trash and paths
Erosion Hazard	44	Calculate Erosion Hazard

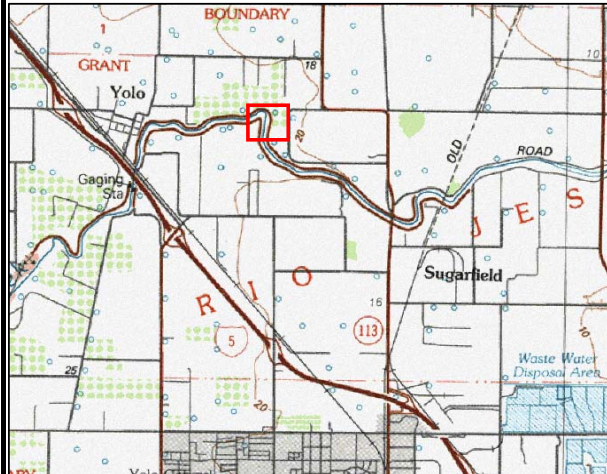
Cache Creek, LM 3.4L

Criteria	Score	Notes
Bank Slope (*2)	4	1:1 slope
Berm Width (*2) - Estimated	2	15 to 30 feet
Location of erosion	4	toe and upper bank
Bank Stability	5	vertical sections, less than half slope height, and caves
Site Relative to Bend	5	outside of a less than 90 degree bend
Vegetation Cover	2	40%
Tree Hazard	0	no trees
Soil Type (*2)	4	sands and silts
Velocity (*2)	4	6.5 ft/s
Human Usage	0	adjacent to private property, rare usage
Erosion Hazard	44	Calculate Erosion Hazard

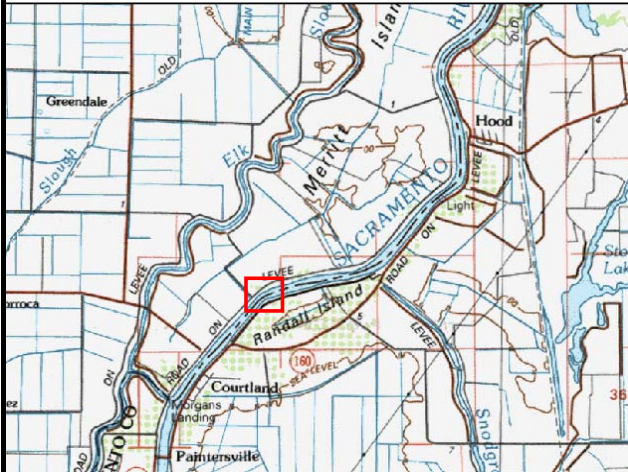
Sacramento River, RM 35.3R

Criteria	Score	Notes
Bank Slope (*2)	3	1.5:1 slope
Berm Width (*2) - Estimated	5	no berm
Location of erosion	2	full bnak
Bank Stability	0	no vertical sections or caves
Site Relative to Bend	3	outside of a greater than 90 degree bend
Vegetation Cover	1	60%
Tree Hazard	0	no trees
Soil Type (*2)	4	sands and silts
Velocity (*2)	4	5.89 ft/s
Human Usage	5	daily
Erosion Hazard	43	Calculate Erosion Hazard

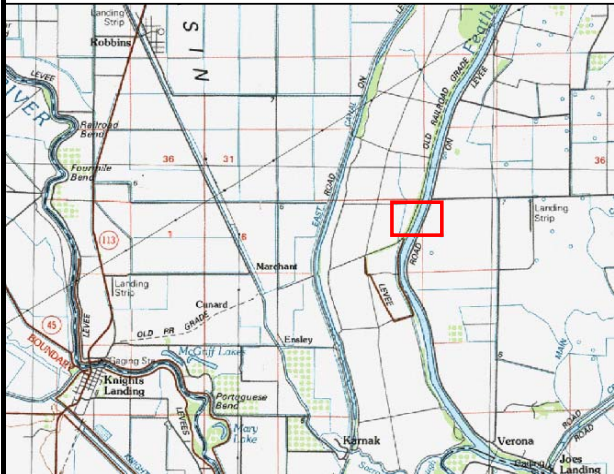
Feather River, RM 3.8L

Criteria	Score	Notes
Bank Slope (*2)	4	1:1 slope
Berm Width (*2) - Estimated	1	25 to 30 ft
Location of erosion	3	whole bank
Bank Stability	3	some holes from trees falling
Site Relative to Bend	1	straight
Vegetation Cover	1	70 to 80%
Tree Hazard	5	large trees with visible roots, some leaning
Soil Type (*2)	4	sands and silts
Velocity (*2)	4	7.08 ft/s
Human Usage	4	adjacent to road, weekly use
Erosion Hazard	43	Calculate Erosion Hazard

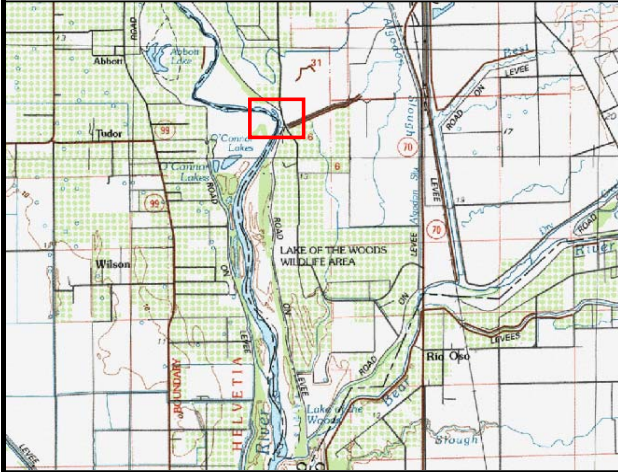
Feather River, RM 17.8L

Criteria	Score	Notes
Bank Slope (*2)	4	1:1 slope
Berm Width (*2) - Estimated	0	50 ft
Location of erosion	3	whole bank
Bank Stability	4	vertical sections for whole bank height
Site Relative to Bend	5	outside of a slightly less than 90 degree bend
Vegetation Cover	2	about 40 to 50%
Tree Hazard	5	large trees, roots exposed, and leaning
Soil Type (*2)	4	sands and silts
Velocity (*2)	3	4.63 ft/s
Human Usage	1	Dumping spot but not much usage
Erosion Hazard	42	Calculate Erosion Hazard

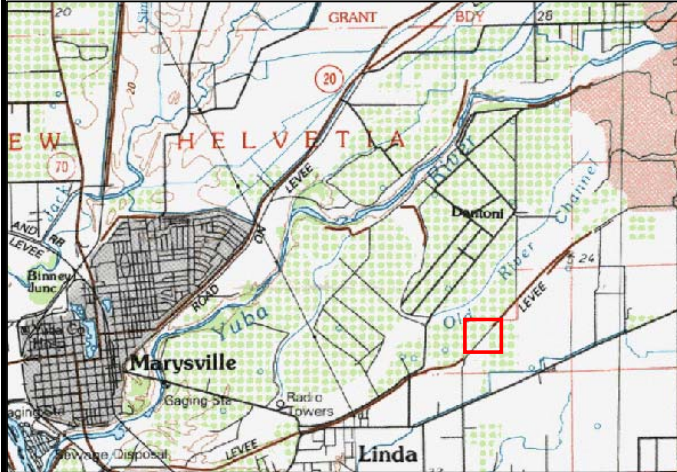
Yuba River, LM 2.3 (DWR MA 8 South)

Criteria	Score	Notes
Bank Slope (*2)	5	near vertical
Berm Width (*2) - Estimated	5	no berm
Location of erosion	4	toe and lower slope
Bank Stability	2	shallow vertical sections
Site Relative to Bend	1	straight
Vegetation Cover	4	minimal
Tree Hazard	0	no trees
Soil Type (*2)	4	sands and silts
Velocity (*2)	0	water does not reach the bank
Human Usage	3	monthly usage
Erosion Hazard	42	Calculate Erosion Hazard

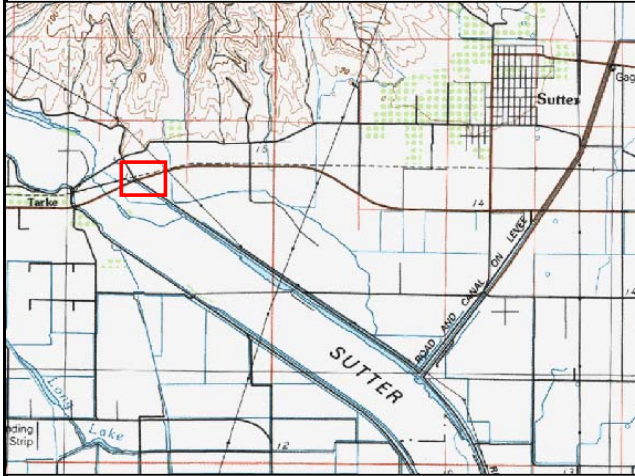
Sutter Bypass, LM 0.4 (DWR East)

Criteria	Score	Notes
Bank Slope (*2)	4	1:1 slope
Berm Width (*2) - Estimated	3	5 to 6 ft of berm
Location of erosion	4	toe and lower slope
Bank Stability	2	some vertical sections, less than half bank height
Site Relative to Bend	1	relatively straight
Vegetation Cover	3	minimal, less than 40%
Tree Hazard	2	medium sized trees
Soil Type (*2)	4	sands and silts
Velocity (*2)	2	3.0 ft/s
Human Usage	4	near road, trash evident, weekly
Erosion Hazard	42	Calculate Erosion Hazard

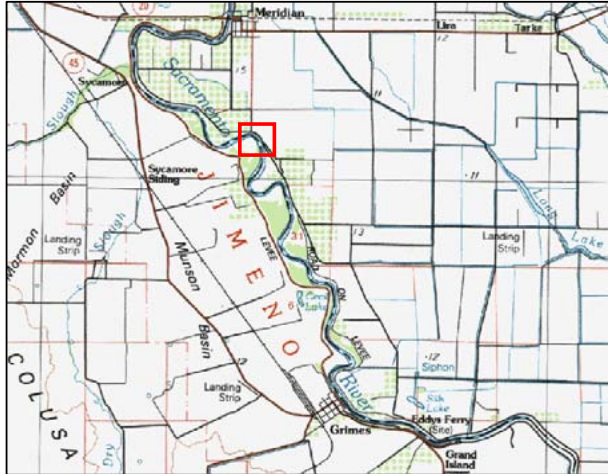
Sacramento River, RM 130.0L

Criteria	Score	Notes
Bank Slope (*2)	3	1.5:1 slope
Berm Width (*2) - Estimated	5	0 to 60 ft
Location of erosion	4	berm slope and toe
Bank Stability	0	no vertical sections or caves
Site Relative to Bend	5	outside of a tight bend
Vegetation Cover	2	50%
Tree Hazard	4	large trees with exposed roots
Soil Type (*2)	2	clays and silts
Velocity (*2)	2	2.86 ft/s
Human Usage	2	seasonal
Erosion Hazard	41	Calculate Erosion Hazard

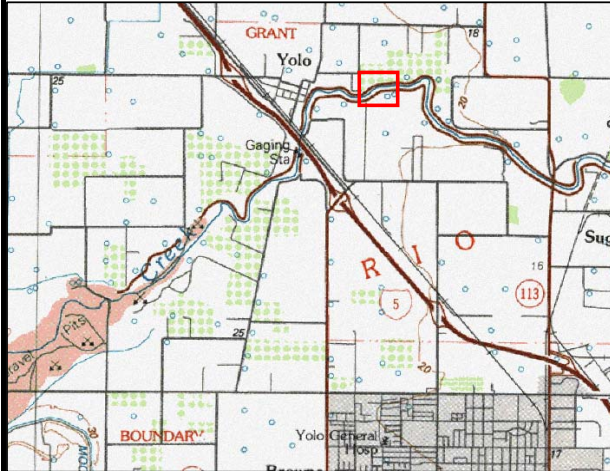
Cache Creek, LM 2.8L

Criteria	Score	Notes
Bank Slope (*2)	4	1:1 slope
Berm Width (*2) - Estimated	0	30 to 50 ft
Location of erosion	2	full bank
Bank Stability	5	vertical sections, greater than half bank height and caves
Site Relative to Bend	1	straight
Vegetation Cover	3	30%
Tree Hazard	3	large trees
Soil Type (*2)	2	clays and silts
Velocity (*2)	3	4.74 ft/s
Human Usage	4	weekly
Erosion Hazard	36	Calculate Erosion Hazard

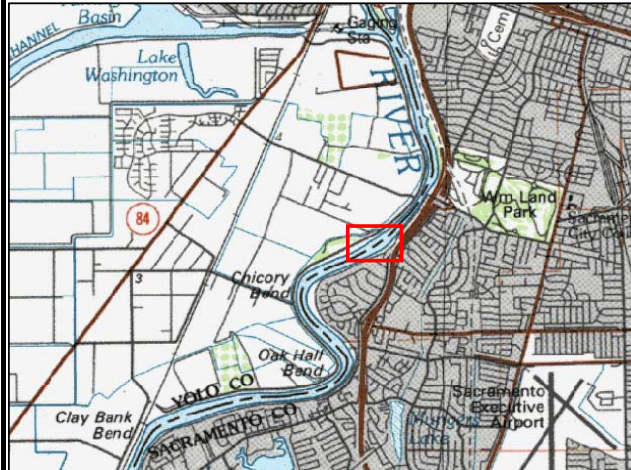
Sacramento River, RM 55.2L

Criteria	Score	Notes
Bank Slope (*2)	2	2:1 slope
Berm Width (*2) - Estimated	3	8 to 10 ft
Location of erosion	2	full bank
Bank Stability	2	vertical sections, less than half bank height
Site Relative to Bend	0	inside of a bend
Vegetation Cover	3	30%
Tree Hazard	3	large trees
Soil Type (*2)	4	sands and silts
Velocity (*2)	3	3.41 ft/s
Human Usage	5	campground adjacent
Erosion Hazard	39	Calculate Erosion Hazard

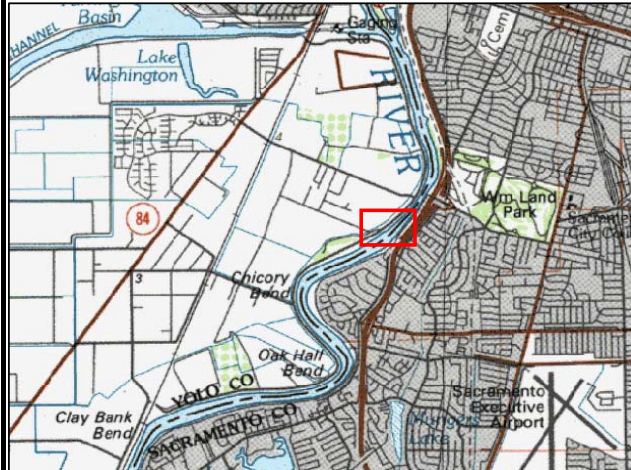
Sacramento River, RM 55.5L

Criteria	Score	Notes
Bank Slope (*2)	3	1.5:1 slope
Berm Width (*2) - Estimated	4	less than 5 ft
Location of erosion	3	toe
Bank Stability	2	some vertical sections, less than half bank height
Site Relative to Bend	1	straight
Vegetation Cover	0	dense, 95%
Tree Hazard	5	trees with exposed roots and leaning
Soil Type (*2)	4	sands and silts
Velocity (*2)	3	4.01 ft/s
Human Usage	0	too dense with vegetation for human use
Erosion Hazard	39	Calculate Erosion Hazard

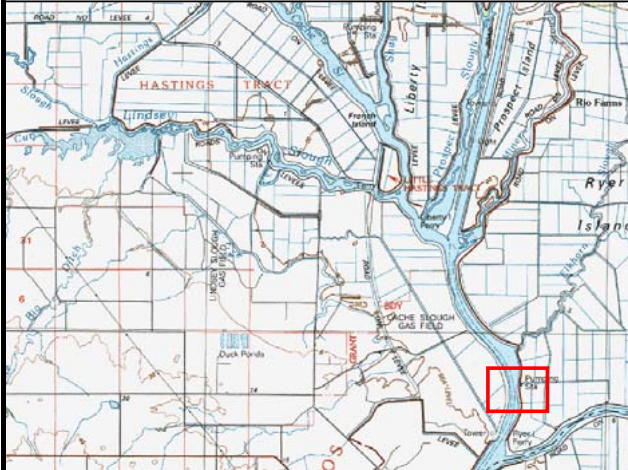
Cache Slough, RM 15.9L

Criteria	Score	Notes
Bank Slope (*2)	3	1.5:1 slope
Berm Width (*2) - Estimated	2	10 ft
Location of erosion	4	berm and toe
Bank Stability	5	vertical sections, full bank height, lots of beaver holes
Site Relative to Bend	1	straight
Vegetation Cover	2	60%
Tree Hazard	0	no trees
Soil Type (*2)	4	sand and silts
Velocity (*2)	3	4.0 ft/s
Human Usage	2	seasonal
Erosion Hazard	38	Calculate Erosion Hazard

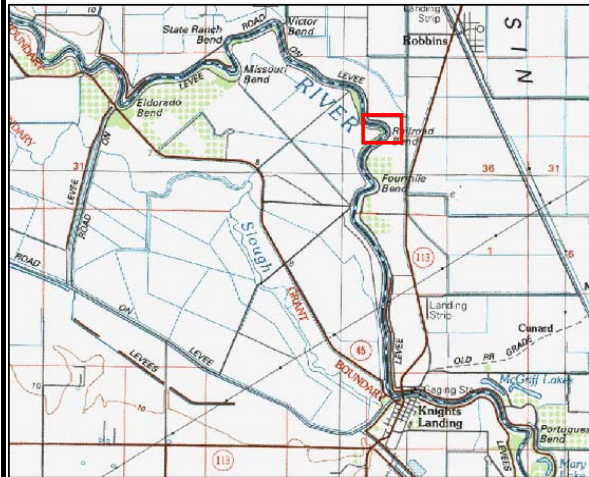
Sacramento River, RM 93.7L

Criteria	Score	Notes
Bank Slope (*2)	3	1.5:1 slope
Berm Width (*2) - Estimated	2	15 ft
Location of erosion	4	toe and bank
Bank Stability	2	vertical sections, less than half bank height
Site Relative to Bend	5	outside of a tight bend
Vegetation Cover	2	60%
Tree Hazard	0	no trees
Soil Type (*2)	4	sands and silts
Velocity (*2)	3	3.37 ft/s
Human Usage	1	daily, stairs and path down
Erosion Hazard	38	Calculate Erosion Hazard

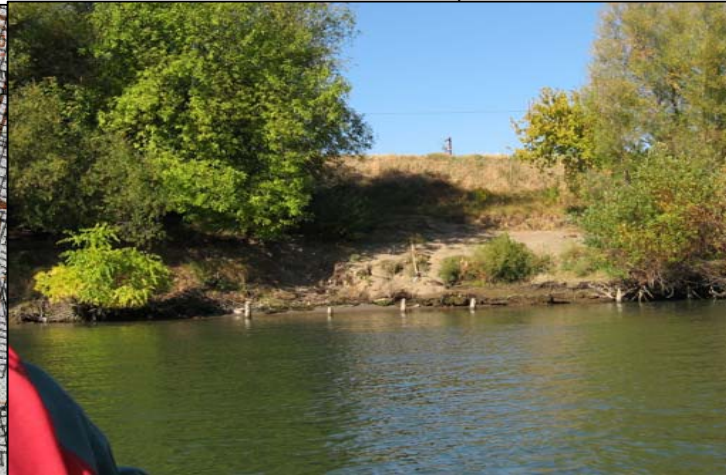
Sacramento River, RM 56.7R

Criteria	Score	Notes
Bank Slope (*2)	3	1.5:1 slope
Berm Width (*2) - Estimated	0	30 to 40 ft
Location of erosion	4	lower bank and toe
Bank Stability	2	short vertical sections
Site Relative to Bend	1	straight
Vegetation Cover	2	60%
Tree Hazard	4	large trees with exposed roots
Soil Type (*2)	4	sands and silts
Velocity (*2)	3	4.88 ft/s
Human Usage	5	daily
Erosion Hazard	38	Calculate Erosion Hazard

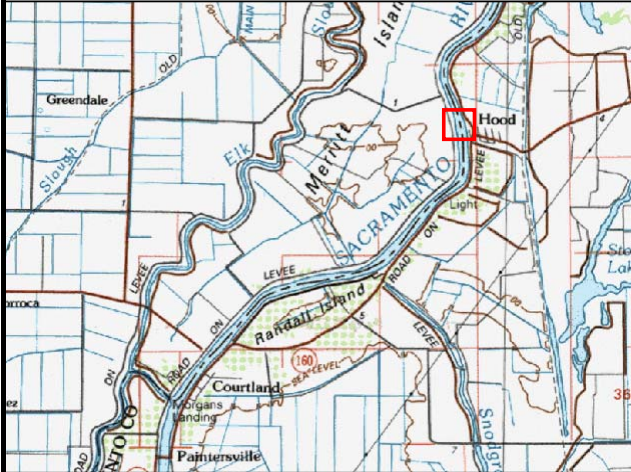
Sacramento River, RM 38.5R

Criteria	Score	Notes
Bank Slope (*2)	3	1.5:1 slope
Berm Width (*2) - Estimated	4	less than 5 ft
Location of erosion	4	lower bank and toe
Bank Stability	2	vertical sections, less than half bank slope
Site Relative to Bend	1	straight
Vegetation Cover	2	40-50%
Tree Hazard	0	no trees
Soil Type (*2)	2	clays and silts
Velocity (*2)	4	5.46 ft/s
Human Usage	3	monthly
Erosion Hazard	38	Calculate Erosion Hazard

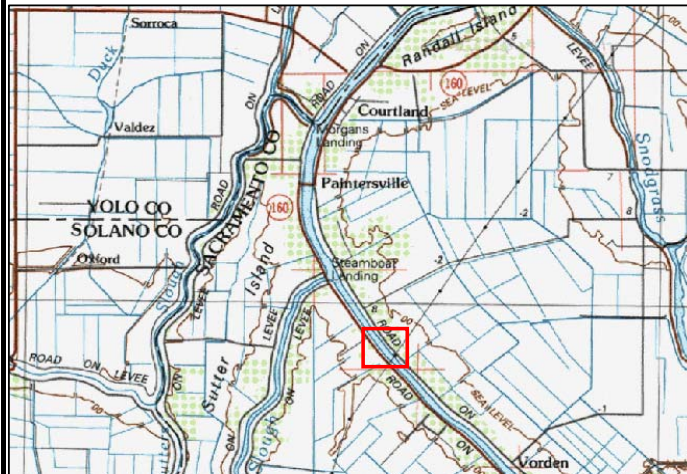
Sacramento River, RM 31.6R

Criteria	Score	Notes
Bank Slope (*2)	3	1.5:1 slope
Berm Width (*2) - Estimated	5	no berm
Location of erosion	1	levee slope
Bank Stability	0	no vertical sections or caves
Site Relative to Bend	1	straight
Vegetation Cover	1	70%
Tree Hazard	0	no trees
Soil Type (*2)	4	sands and silts
Velocity (*2)	4	5.23 ft/s
Human Usage	3	adjacent to road but no paths, monthly
Erosion Hazard	38	Calculate Erosion Hazard

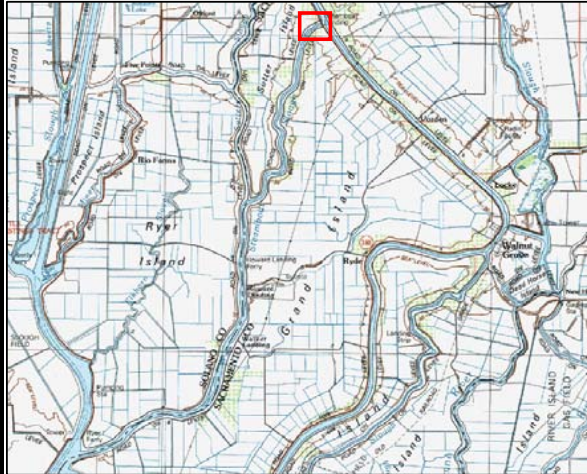
Steamboat Slough, RM 26.0L

Criteria	Score	Notes
Bank Slope (*2)	3	1.5:1 slope
Berm Width (*2) - Estimated	3	5 ft
Location of erosion	4	lower bank and toe
Bank Stability	1	caves from tree popouts
Site Relative to Bend	0	inside of a bend
Vegetation Cover	3	40%
Tree Hazard	5	large trees, exposed roots and leaning
Soil Type (*2)	2	clays and silts
Velocity (*2)	3	4.76 ft/s
Human Usage	3	monthly
Erosion Hazard	38	Calculate Erosion Hazard

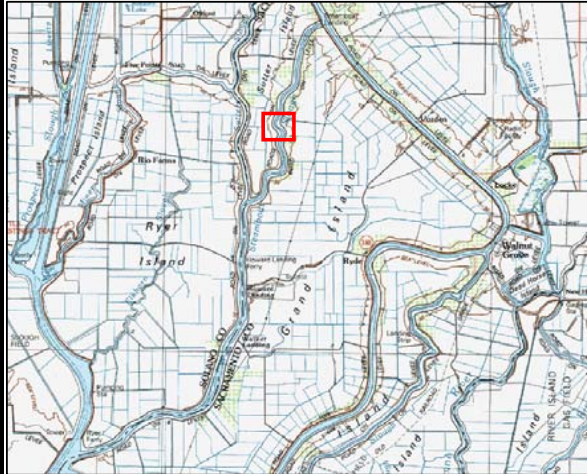
Steamboat Slough, RM 23.9R

Criteria	Score	Notes
Bank Slope (*2)	2	2:1 slope with some vertical sections
Berm Width (*2) - Estimated	1	25 to 30 ft
Location of erosion	3	whole bank
Bank Stability	2	vertical sections, less than half bank height
Site Relative to Bend	1	straight
Vegetation Cover	3	30 to 40 % cover
Tree Hazard	0	no trees in the erosion area
Soil Type (*2)	4	sands and silts
Velocity (*2)	5	10.6 ft/s
Human Usage	5	close to road, human debris evident
Erosion Hazard	38	Calculate Erosion Hazard

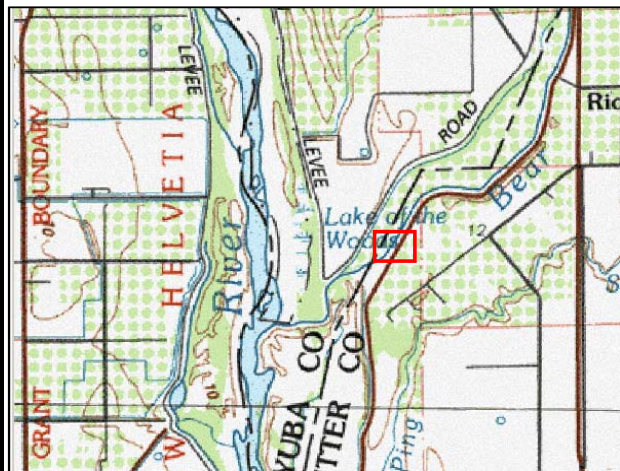
Bear River, RM 0.8L

Criteria	Score	Notes
Bank Slope (*2)	5	Vertical slope
Berm Width (*2) - Estimated	2	15 to 30 ft of berm
Location of erosion	5	Whole Bank
Bank Stability	5	vertical sections and beaver burrows
Site Relative to Bend	3	Outside of a bend, greater than 90 degrees
Vegetation Cover	2	About 60% cover
Tree Hazard	0	no trees
Soil Type (*2)	2	Clays and Silts
Velocity (*2)	2	2.84 ft/s
Human Usage	1	Occassional usage
Erosion Hazard	38	Calculate Erosion Hazard
